Building Collapse in Nigeria: A Review and Delivery of the Future Using Big Data & IOT

Dr. Umbugala Muhammad Douglas

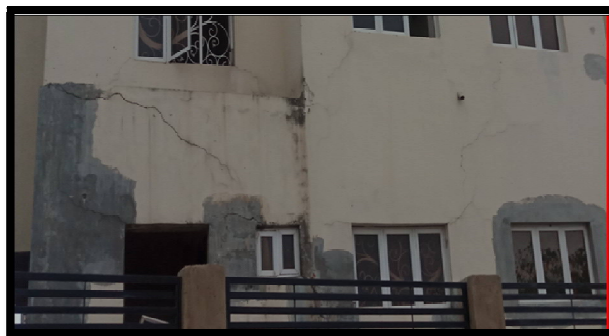
Figure 1 presents large diagonal crack ripping across the ground floor walls of the left side of the structure. The diagonal crack has wider opening at the top and smaller gap towards the bottom right which is a clear indication that the foundation under the left side has entertained some amount of settlement (sinkage). Foundation settlement, particularly when it affects some parts of the foundation, leaving the other parts unaffected (known as uneven settlement) will normally depicts cracks of the nature seen in the Figure below.

Figure 1: Diagonal Crack Resulting from Foundation Settlement

Cracks caused by uneven settlements are usually progressive both in extent (length) and width. The rampant cement-mortar work patches (shown in the darker portions) displays further possible frantic efforts towards curtailing the consequence of the deteriorating condition of this part of the structure. In this respect, additional diagonal cracks could be sighted on the right-side portion of the structure.

Foundation settlements are purely structural problems and these usually pose serious threats to occupants as well as their belongings. Unless fully addressed immediately, these cracks will keep on increasing in length and width until partial or total collapse occurs.

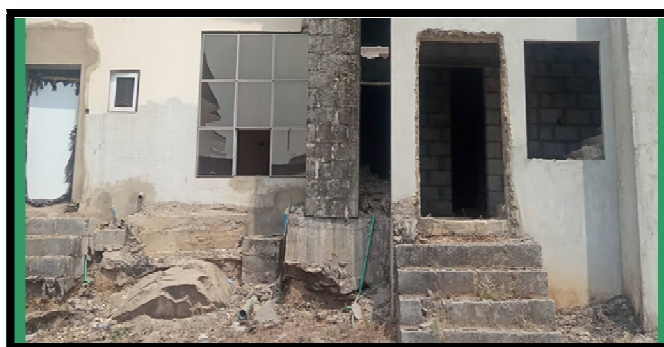
Figure 2 below presents typical place where foundations were footed on loose soil at ground surface levels. The soil was found to be so soft that it can be removed using ordinary bare hand. This background doesn't look like a newly constructed structure.

Figure 2: Footing Bases Composed of Loose Soil

Indeed, placing foundations on the surface of the ground or close to surface without digging proper trench could surely attract settlement especially where the ground is of vegetable soil nature. Another serious threat could be from lateral loading such as wind or storm forces. In fact, buildings or parts of the buildings whose foundations remain at surface or close to surface levels could entertain sway or complete uproot.

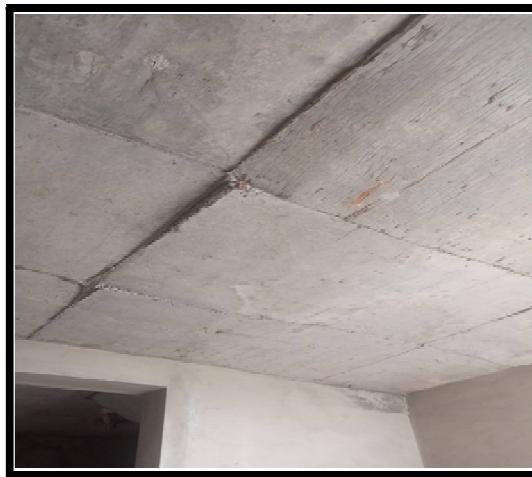
Figure 3 below however depicted typical suspended floor cast on an uneven platform of formwork. The soffit of the hardened floor therefore assumed the uneven surface of the formwork. Similar abnormalities were witnessed in many places and these could attract serious increase in weight from possible plaster fill up. The use of thick plaster is obviously necessary in order to make even the soffits of the concrete floors. The increased thicknesses not only reduce headroom but also contribute to the weight of the floors with consequent rise in the overall weight of the structure.

Figure 3: Soffit of Poorly Constructed Suspended Concrete Floor

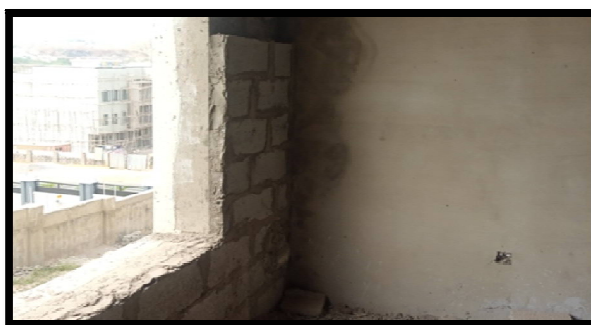
Building sway is definitely an eyesore to observers and more importantly scaring to occupants. A look from the tarred road passing in front of the 'Plot' in an axis parallel to the front side of the erected structure revealed some amount of sway particularly towards the end of the structure. It isn't surprising when the inventory team stumbled on what looks like cladding but using blocks, while in actual sense it is a way of making up a wall that has deviated from its bearing or real standing position. Figure 4 below presents increase in wall thickness using parts of locks.

Figure 4: Increase in Wall Thickness through Cladding with Blocks

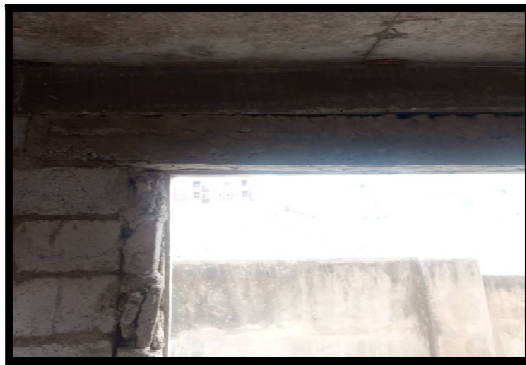
It is to dismay of the inventory team that, there are many members in the structure which entertained some amount of sagging. The worst hit in this form of structural defect are window openings. Figure 5 below displays typical sagging at window opening where the precast lintel curved downwards.

Figure 5: Sagging at Window Opening

Generally sagging demonstrates structural deficiency associated with the sagged member. Reasons leading to sagging could be (i) under reinforcement, (ii) use of inferior materials, (iii) construction of undersized member, (iv) poor workmanship, and (v) over loading. In this respect, it takes diligent and experience inventory experts to ascertain violation with regards to items (i) and (ii), evidently, items (iii), (iv) and (v) which were observed and confirmed.

Consequences of sagging in structural members in buildings include excessive downward pressure on windows and doors making creaking noise during opening, formation of cracks thereby aiding reinforcement corrosion due to ingress of moisture, member inability to effectively perform its intended designed function as well as partial or total collapse.

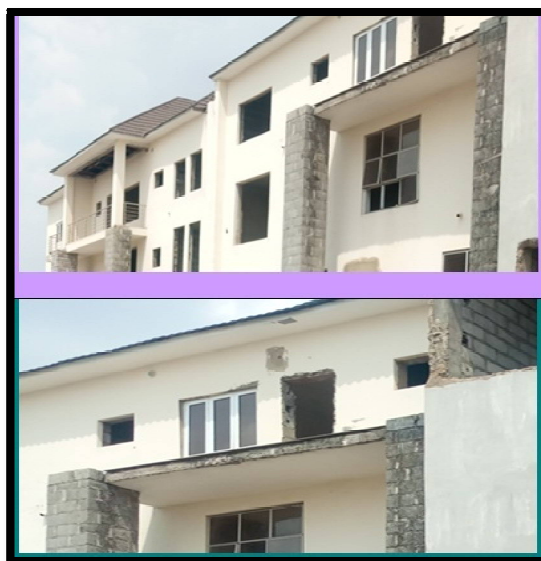
Figure 6 below presents upper portion of the front elevation where two vertical white painted columns appeared on the left side and not on the right. Critical exploration confirmed the existence of similar columns on the right but abruptly removed most likely due to eminent danger of collapse. One could imagine all these happening without the interception by any of the regulatory and monitoring teams?

Figure 6: Removed Columns in Fear of Collapse
