Abutment Failure and Remedy in Gombe State Nigeria

The bridge in the case study failed due to a similar problem as stated above. The failed bridge is a simply supported bridge beam deck system, saddle with an unreinforced mass concrete abutments structure with both ends fixed on spread footing base. The paper presents a remedy to abutment failure by using a similar parameter and loading condition of the study area through a critical structural analysis, considering functionality and also adherence to British standard in order to serve as guide for further abutment design in the construction industry.

Finally, the failure of Kwando Liji Kurba Bridge Gombe, Gombe State has prompted the need for this research work, following a routine visual inspection of Nigeria bridges under the mandate of Nigeria Building and Road Research Institute. Kwando Liji Kurba Bridge Gombe, Gombe State is a bridge that was shot down to traffic due to Abutment failure.

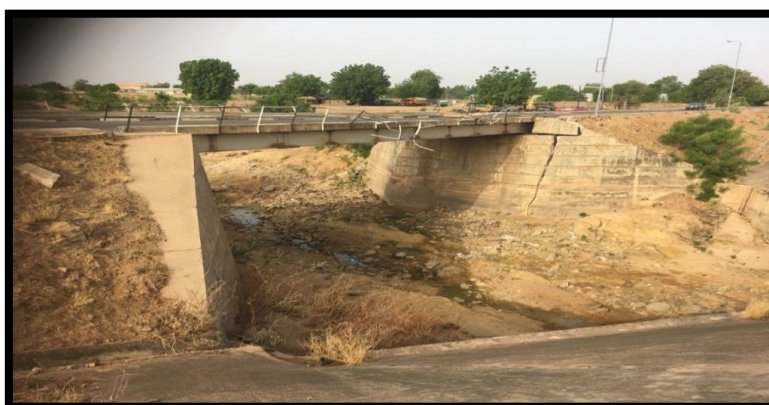
Figure 2: Image Showing Tilted Abutment

Inspection was carried out on the shut-down bridge which is on a Federal Highway. Photographs, measurement and sketches were conducted. Problem attributed to the bridge deck are road approaches and often the most obvious to the inspecting engineers as they are easily identifiable and apparent. An extensive crack appeared on both the section of the road passing both 2 lanes sides. The abutment movement is obvious upon inspection as a severe crack occurred at the west side abutment which seem to be originally from embanked rock boulders replaced after road drains delivers it flood against the unprotected embanked material and wash it off.

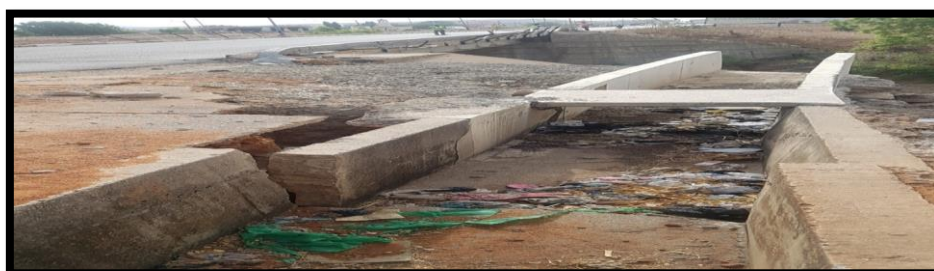
Figure 3: Image Showing Drainage Effect against the Abutment

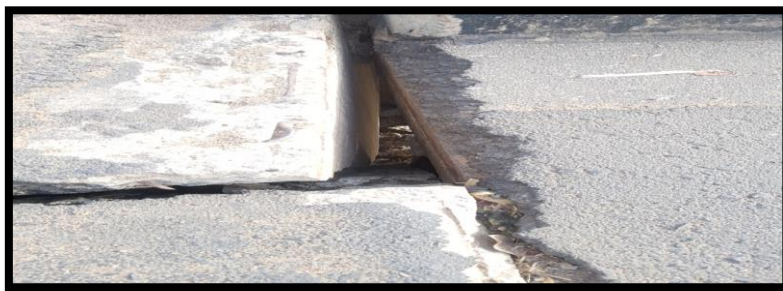
Figure 4: Image Showing Abutment Movement from Bridge Deck

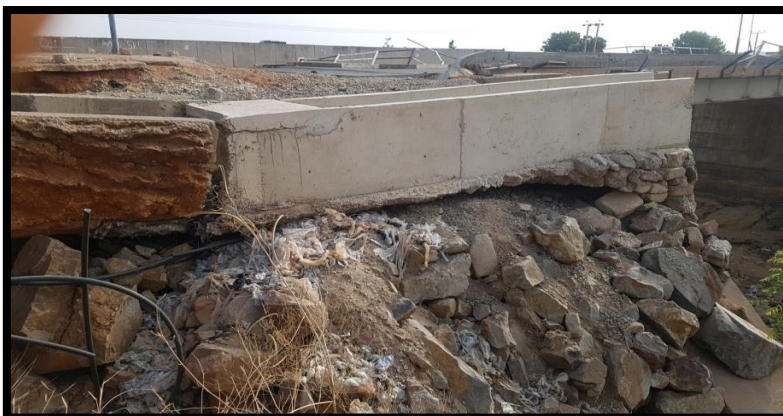
Figure 5: Image Showing Boulders Dump against Abutment
